# Panoramic Night Vision Goggle Testing for Diagnosis and Repair

**Peter L. Marasco and H. Lee Task**

Air Force Research Laboratory
Human Effectiveness Directorate
AFRL/HECV
2255 H. Street
Wright-Patterson AFB, OH 45433-7022
(937) 255-7602

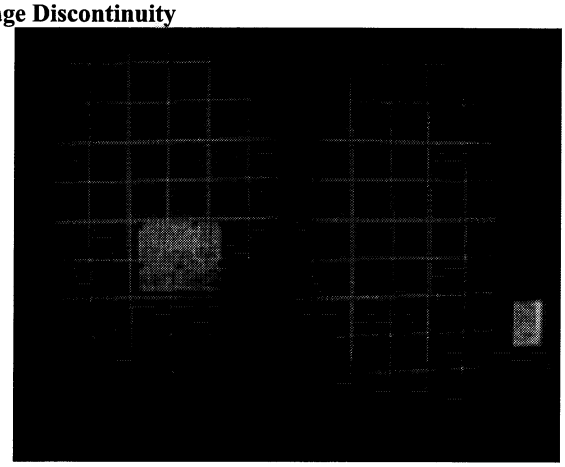
Figure 1. PNVG II image discontinuity before repair.

Since the manufacturer's procedure for adjusting image intensifier tube gain was unknown, changing the relative position of the tube to the eyepiece, thus changing PNVG image discontinuity, was considered possible during repair. Image discontinuity photos taken before and after repairs were compared (Figure 1 and Figure 2). Little change was noted in photos of either PNVG I or PNVG II.

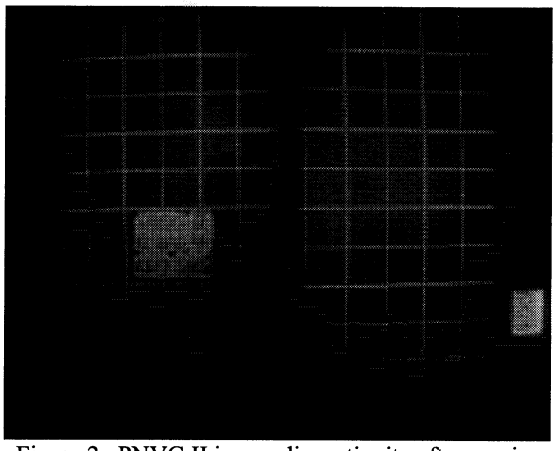
Figure 2. PNVG II image discontinuity after repair.

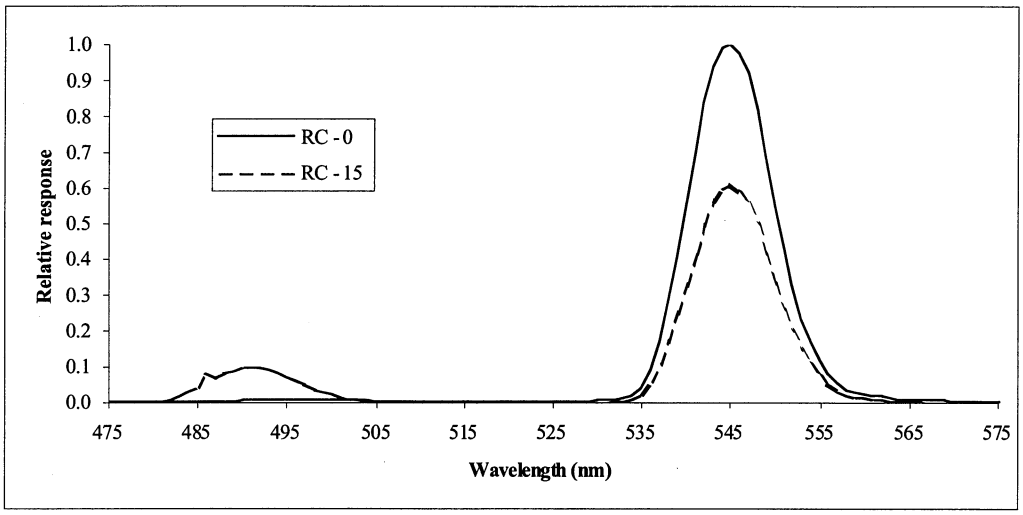
**Spectral Measurements**
Figure 3 shows the spectral distribution for PNVG II, Configuration 4, serial number 0003, on axis and 15 degrees off axis. The spectral measurements indicate that the current filter is sufficient to block the blue and red side lobes on axis. However, at 15 degrees off-axis the blue side lobe appears. The intensity of the blue lobe ranged from 2% to 17% of the corresponding green primary emission depending on the ocular.

Figure 3. Normalized spectral measurements of PNVG II, Config. 4, S/N 0003, Right Central Channel, at 0 and 15 degrees off axis.
